# Manhole Inspection Summary

Manhole # S43I\_\_030MH

**Location** Address: **1517 S Dallas St**

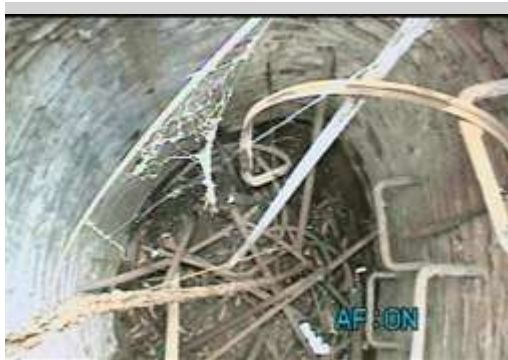
Defect 3

Condition: ☐ Sound ☐ Cracked ☐ Root Intrusion ☐ Deteriorated ☐ Leaks ☒ **Debris**

channel debris

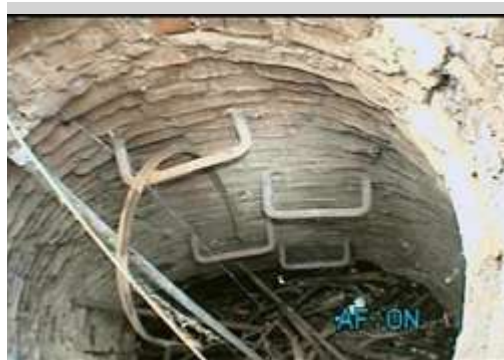
Defect 2

Count: **4** Missing: **0** ☒ **Corroded**

corroded stairs

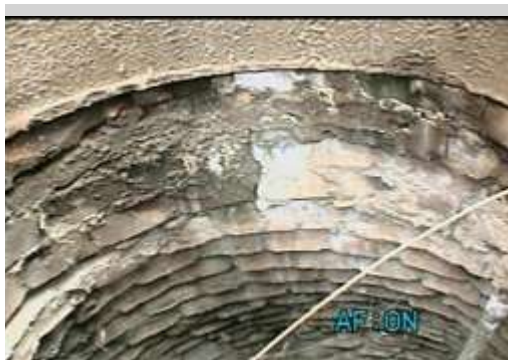
Defect 1

Condition: ☐ Sound ☐ Cracked ☐ Root Intrusion ☒ **Loose Brick** ☒ **Deteriorated**

Condition: ☐ Sound ☒ **Cracked** ☐ Root Intrusion ☐ Loose Brick ☐ Deteriorated

chimney deteriorated with loose brick,  
crack in corbel

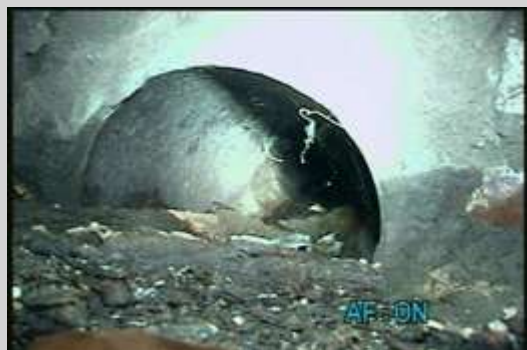
12 O'Clock Outflow

8 in. Circular Gravity Sewer  
Pipe Out @ 12 O'Clock

Deposits: ☐ None ☐ Mud ☐ Sludge ☒ **Debris** ☐ Grease

Silt Depth: **2** (in.) Deposits Extent: **Medium**
